User-Led Accessibility Audit (ULAA) Grand Report

Date of Audits: Summer 2024

Report written by Faolán Doecke-Launders and Declan Treanor

Date of Grand Report: 11 August 2025

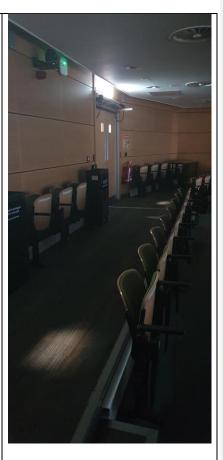
No suitable accessible seating arrangements are present in Stanley Quek or Tercentenary Hall lecture theatres. Desks are present at the front of each theatre but these are impractical due to the location of the projector. Users have cited neck pain as a result.

Plans are in motion to create accessible seating areas at the back of these teaching spaces following the approval of funding. Keep updated on the works.
