User-Led Accessibility Audit Report:

Áras An Phiarsaigh

Date Of Audit: **June 2024**

Area Zone: **6**

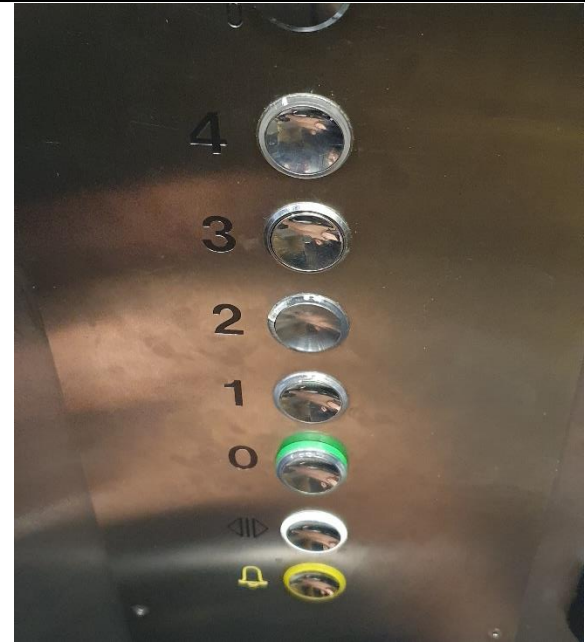
or heavy couches, and no flexible soft seating or alternative postures.	seating to accommodate different physical and sensory needs.	
High-Contrast Signage	Some signs have poor colour contrast under certain lighting / material combinations.	Consider updating older signage, particularly those using metallic bases.	N/A
Lift Buttons	The lift lacks braille/embossed buttons.	Consider braille.

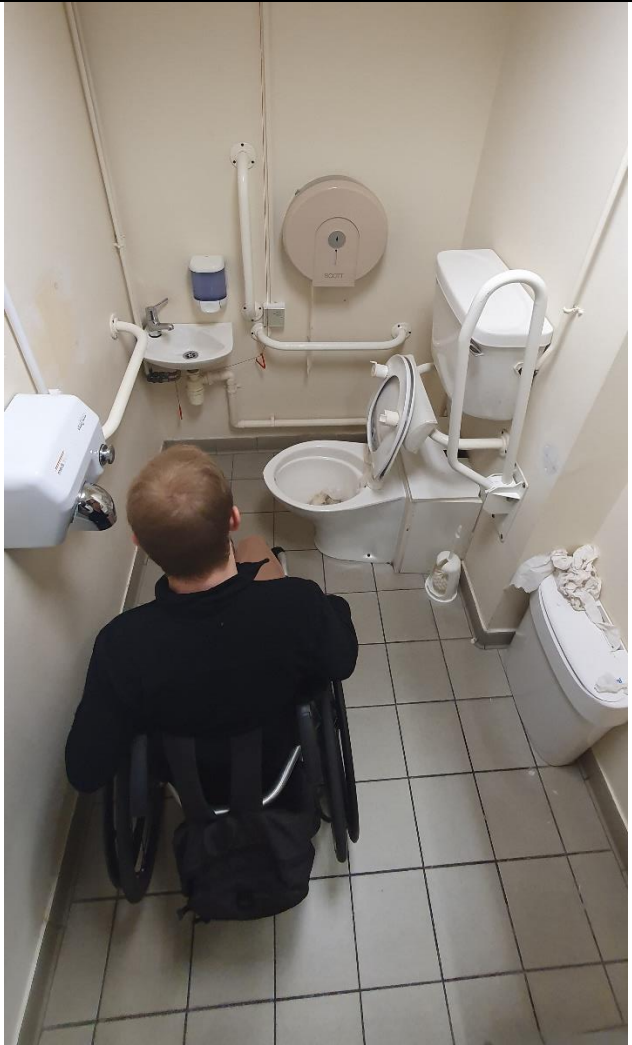
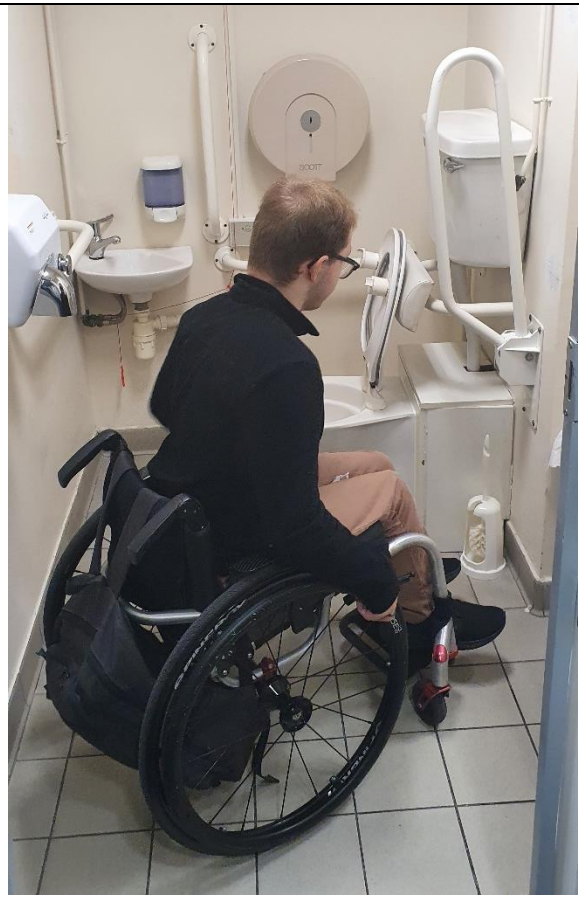
<p>Accessible WCs</p>	<p>There are many issues with the Accessible WCs.</p> <p>The accessible toilet has obstructive handrail placement, insufficient turning space, a poorly placed sink, no automated door, and lacks contrasting grab rails.</p> <p>These limit ease of use and safety.</p>	<p>Consider reconfiguring the WC layout to improve space and movement, relocate the sink for frontal access</p> <p>Recolour grab rails to be contrasting.</p> <p>Automated the door.</p>
